SUPPLY POND DAM

NH 00123

PHASE I INSPECTION REPORT  
NATIONAL DAM INSPECTION PROGRAM

FEBRUARY 1979

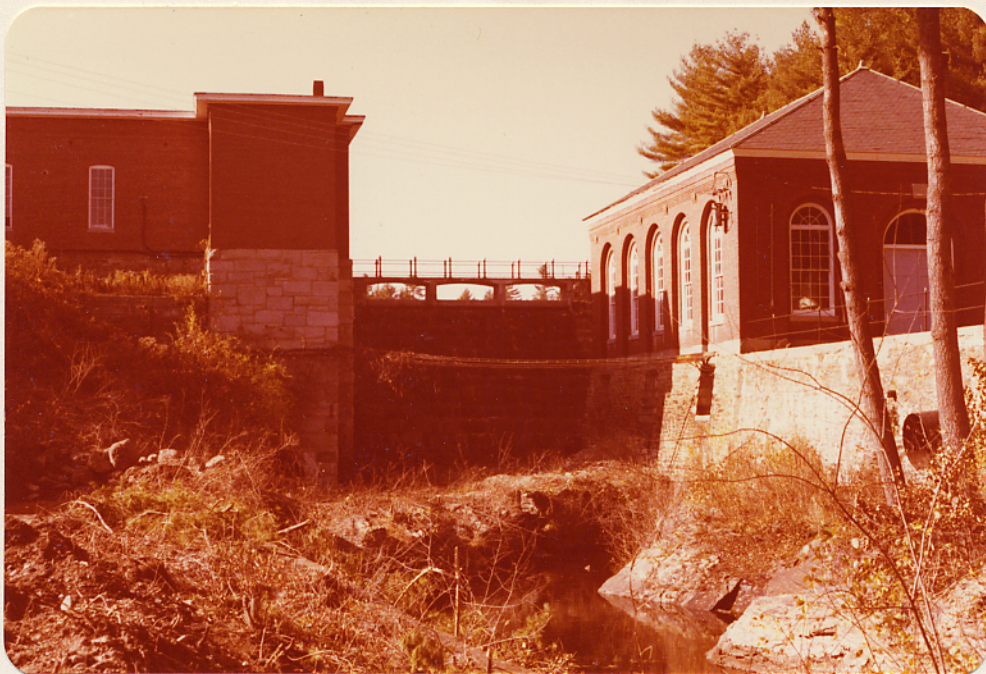
Overview of spillway from downstream channel

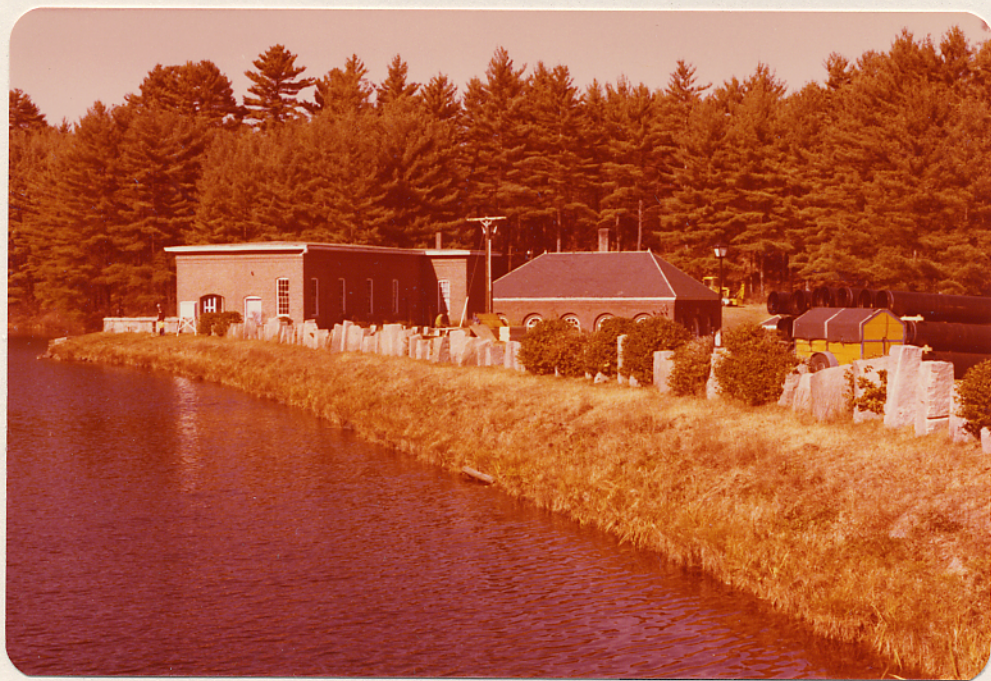
Overview of dam from right abutment upstream

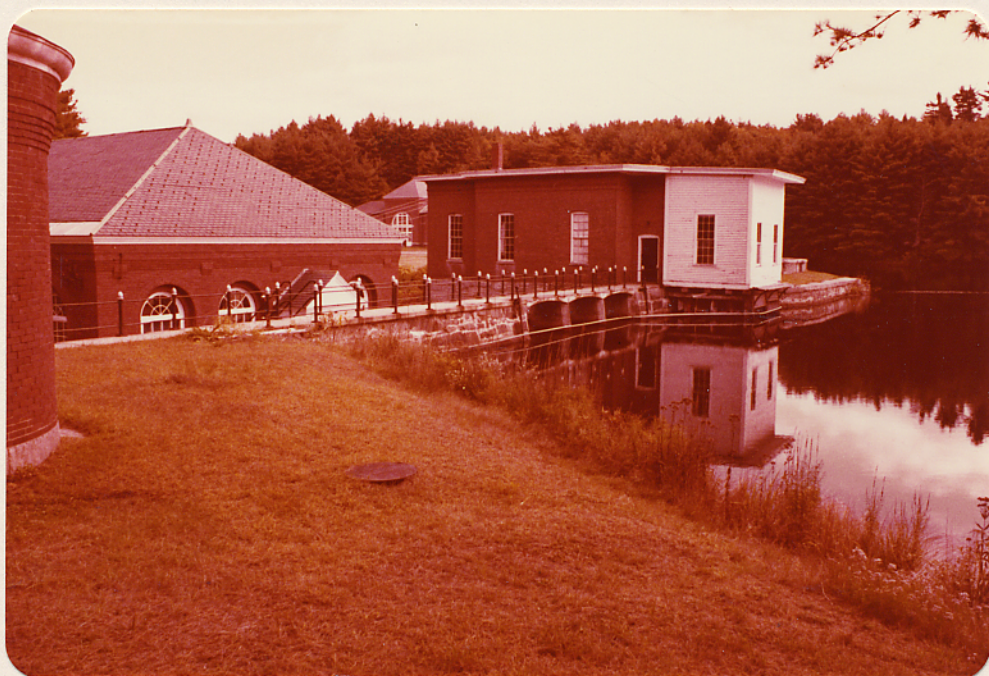
Overview of dam from left upstream side

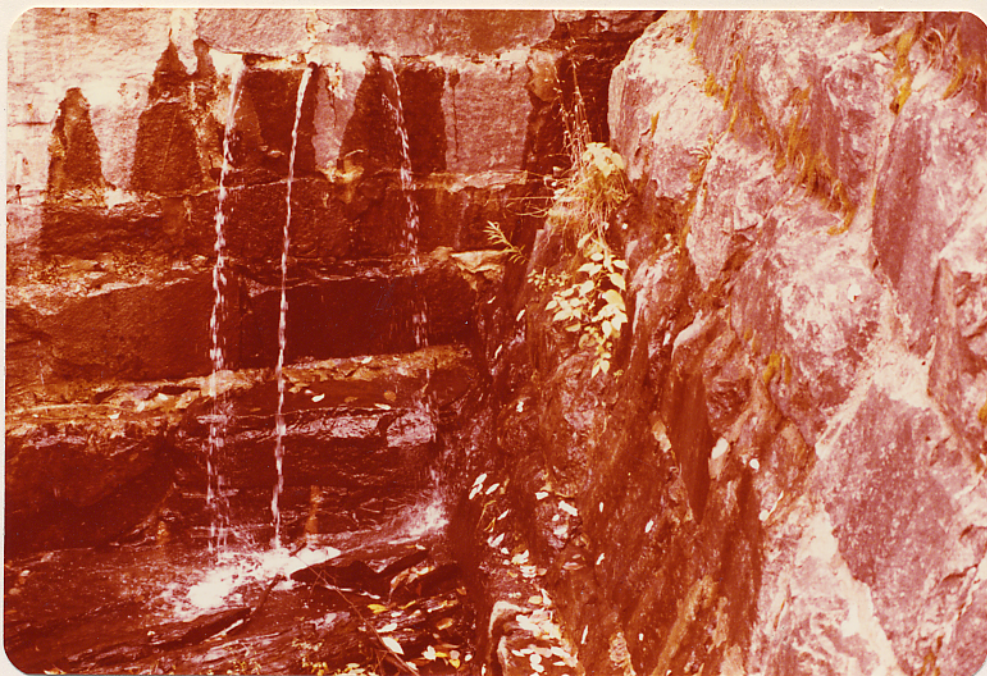
The left sidewall at Pump Station No. 1 has a drain pipe approximately 6 feet above the channel bed with active seepage through the pipe. There is also joint seepage on this sidewall of the building. This seepage and the active drain pipe confirms the fact that a large amount of seepage is flowing through the upstream face of the foundation wall. The seepage discharging through the left sidewall is at the rate of 10 to 20 gpm.

1. View of seepage through wall of old powerhouse at junction with right side of spillway and through face of dam at same location

- (a) Clean debris from around sluice gates outletting through the spillway structure. Service and operate sluice gates at regular intervals.
- (b) Point all stone masonry, as necessary, to arrest seepage through the spillway structure and the building foundation wall.
- (c) Remove the wood frame gate house.
- (d) Institute a program of annual technical inspection of the dam.
- (e) Develop a formal warning system to alert downstream people in case of emergency.
- (f) Clear trees and debris from downstream channel.
- (g) Monitor seepage for change in quantity of flow.
- (h) Repair all spalled concrete.
- (i) Check outlet gates to determine the cause of leakage and repair if necessary.

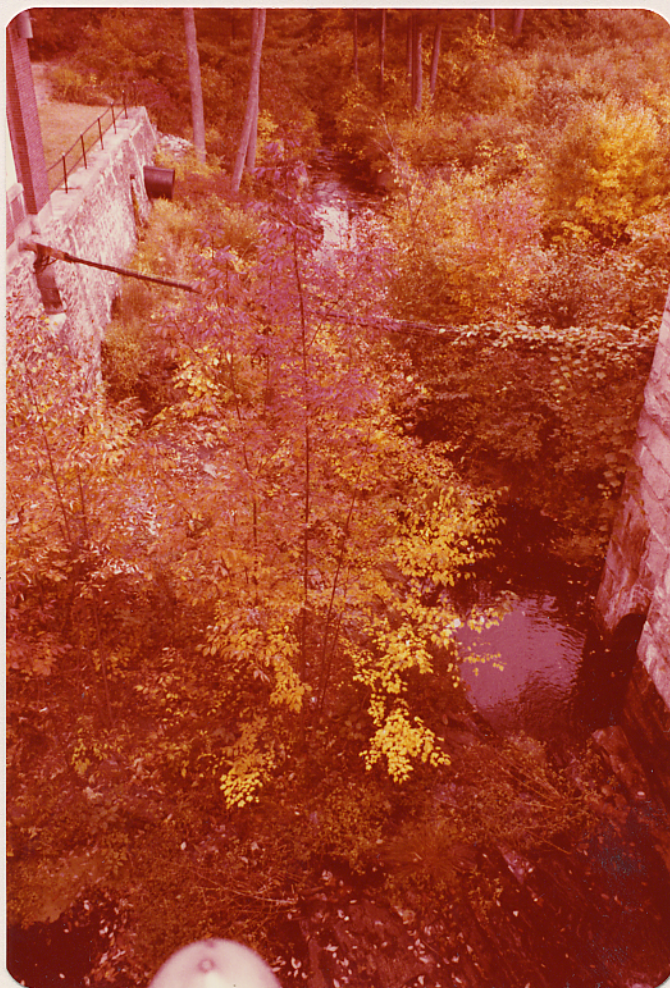
2. View of downstream channel from top of dam

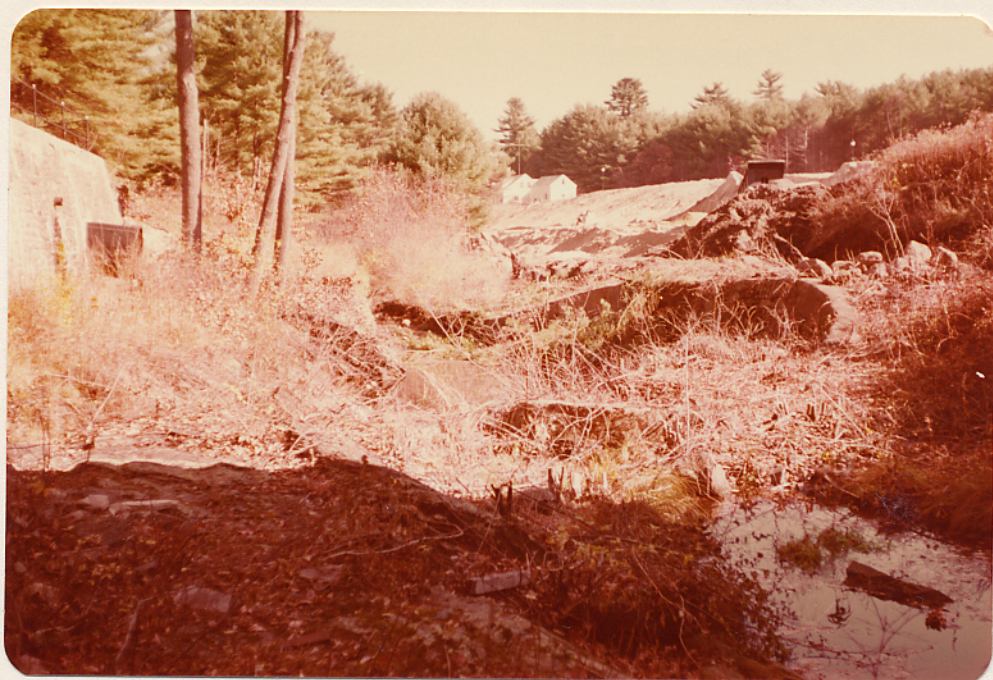
3. View of water treatment plant earthwork  
on right side of downstream channel

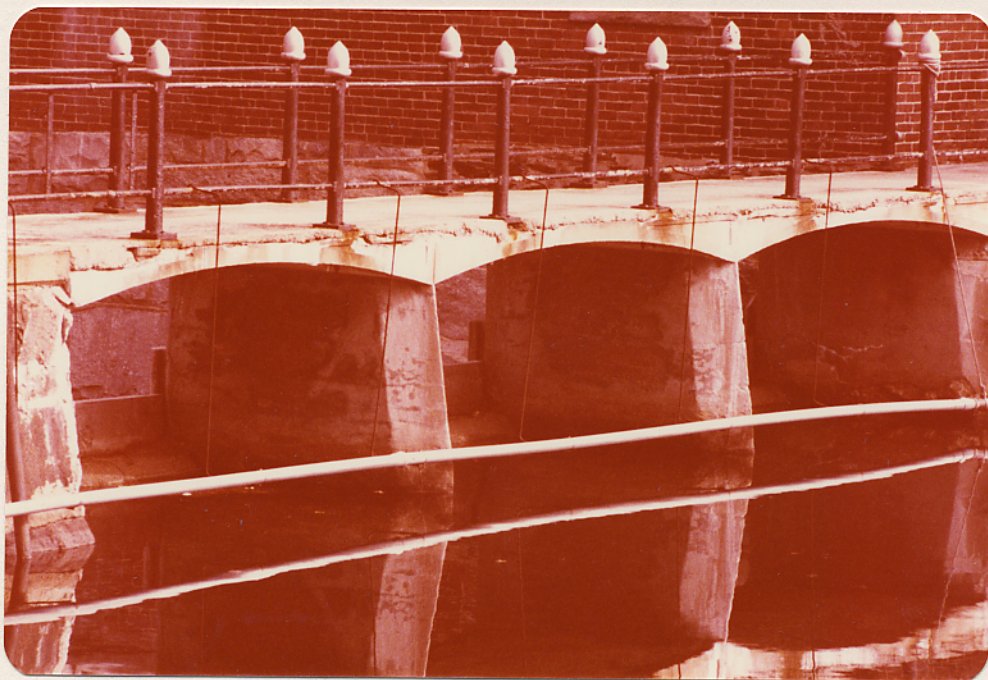
The three span service bridge structure deck exhibits minor surface spalling and a transverse crack. The spalling can be attributed to excessive surface trowelling of concrete and the random cracks can be attributed to expansion of the concrete deck. There is also considerable random surface cracking and efflorescence on the underside and at the fascias of this service bridge.

4. View of concrete deterioration on spillway  
piers and service bridge

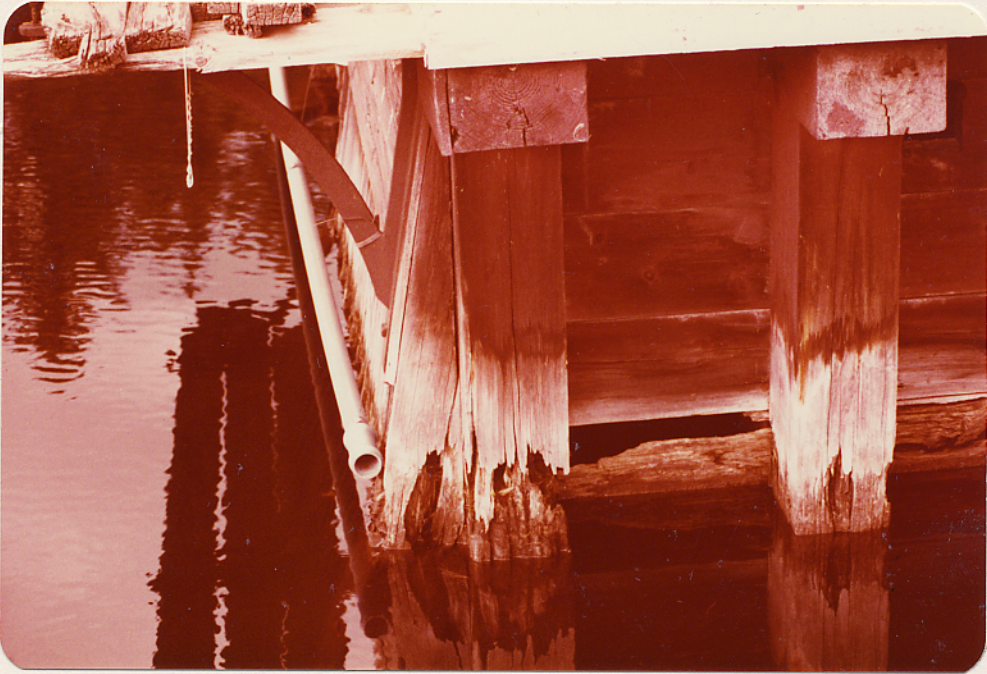
The gate house itself is in POOR condition. The timber columns and framing supports exhibit a high degree of rot. The gates which were located in this building have completely deteriorated. At the present time the main floor of this structure is being used for storage.

5. View from upstream of general deterioration of old timber gatehouse controlling intake to old powerhouse
